Subject: CR Kendall Post-Closure Environmental Impact Statement  
Effects of Historic and Modern Mining on Sediments and Water Quality  
in the Off-Site Mine Area Drainages

# CR Kendall Post-Closure EIS

## **Effects of Historic and Modern Mining on Sediment and Water Quality in the Off-Site Mine Area Drainages**

February 10, 2004

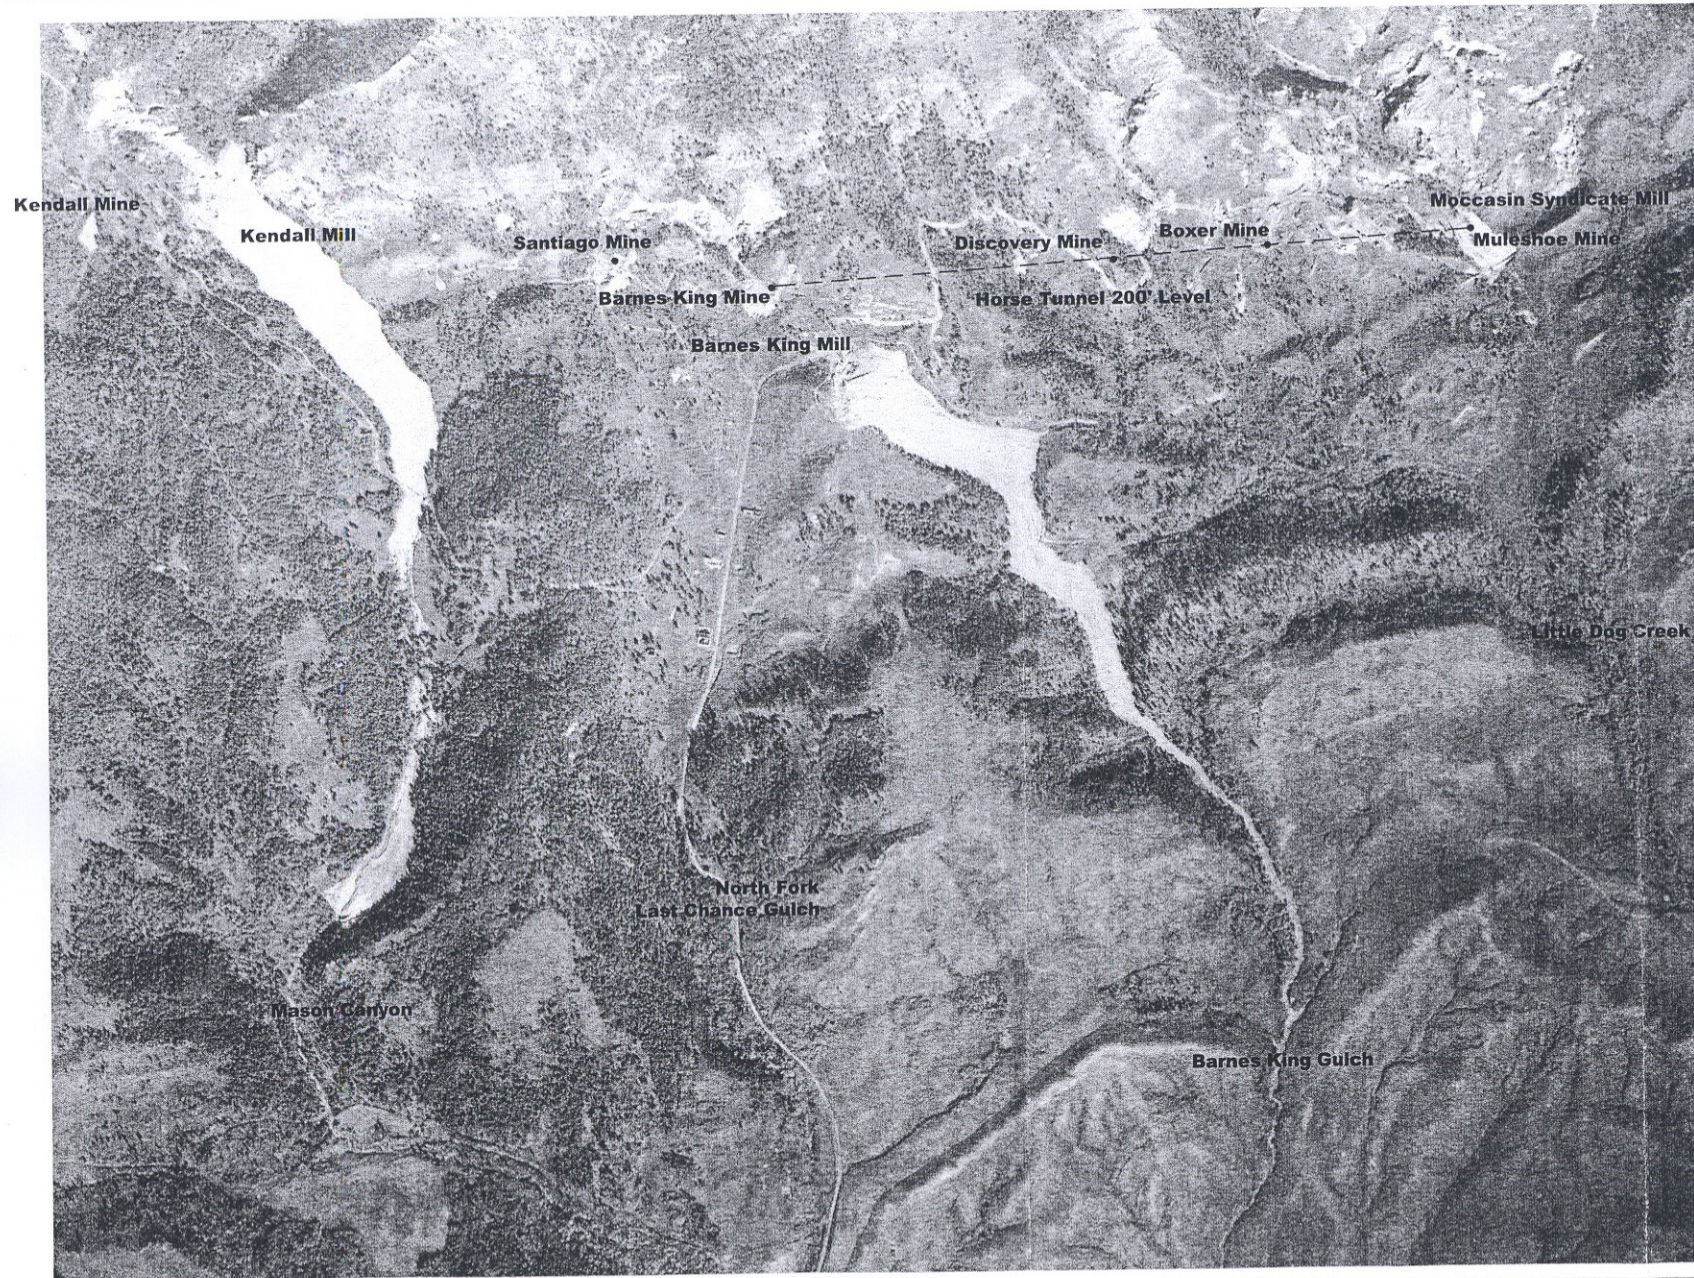
The 12 vat leaching house of the new mill was located on a very steep hillside (Sanborn, 1902, 1905, and 1908 Figures 3-1 through 3-3), presumably to facilitate more efficient removal of the tailings from the vicinity of the mill site. In later years, tailings were discharged from the vat house by use of a tailings elevator due to the height of the growing tailings pile (see Figure 3-4).

Figure 3-4  
View of the Kendall Mill and Mine Looking Southwest (Circa. 1909). Note the Tailings in the Left Foreground and the Waste Rock in the Center Background. (Photo by G.C. Morton, Courtesy of Montana Historical Society)

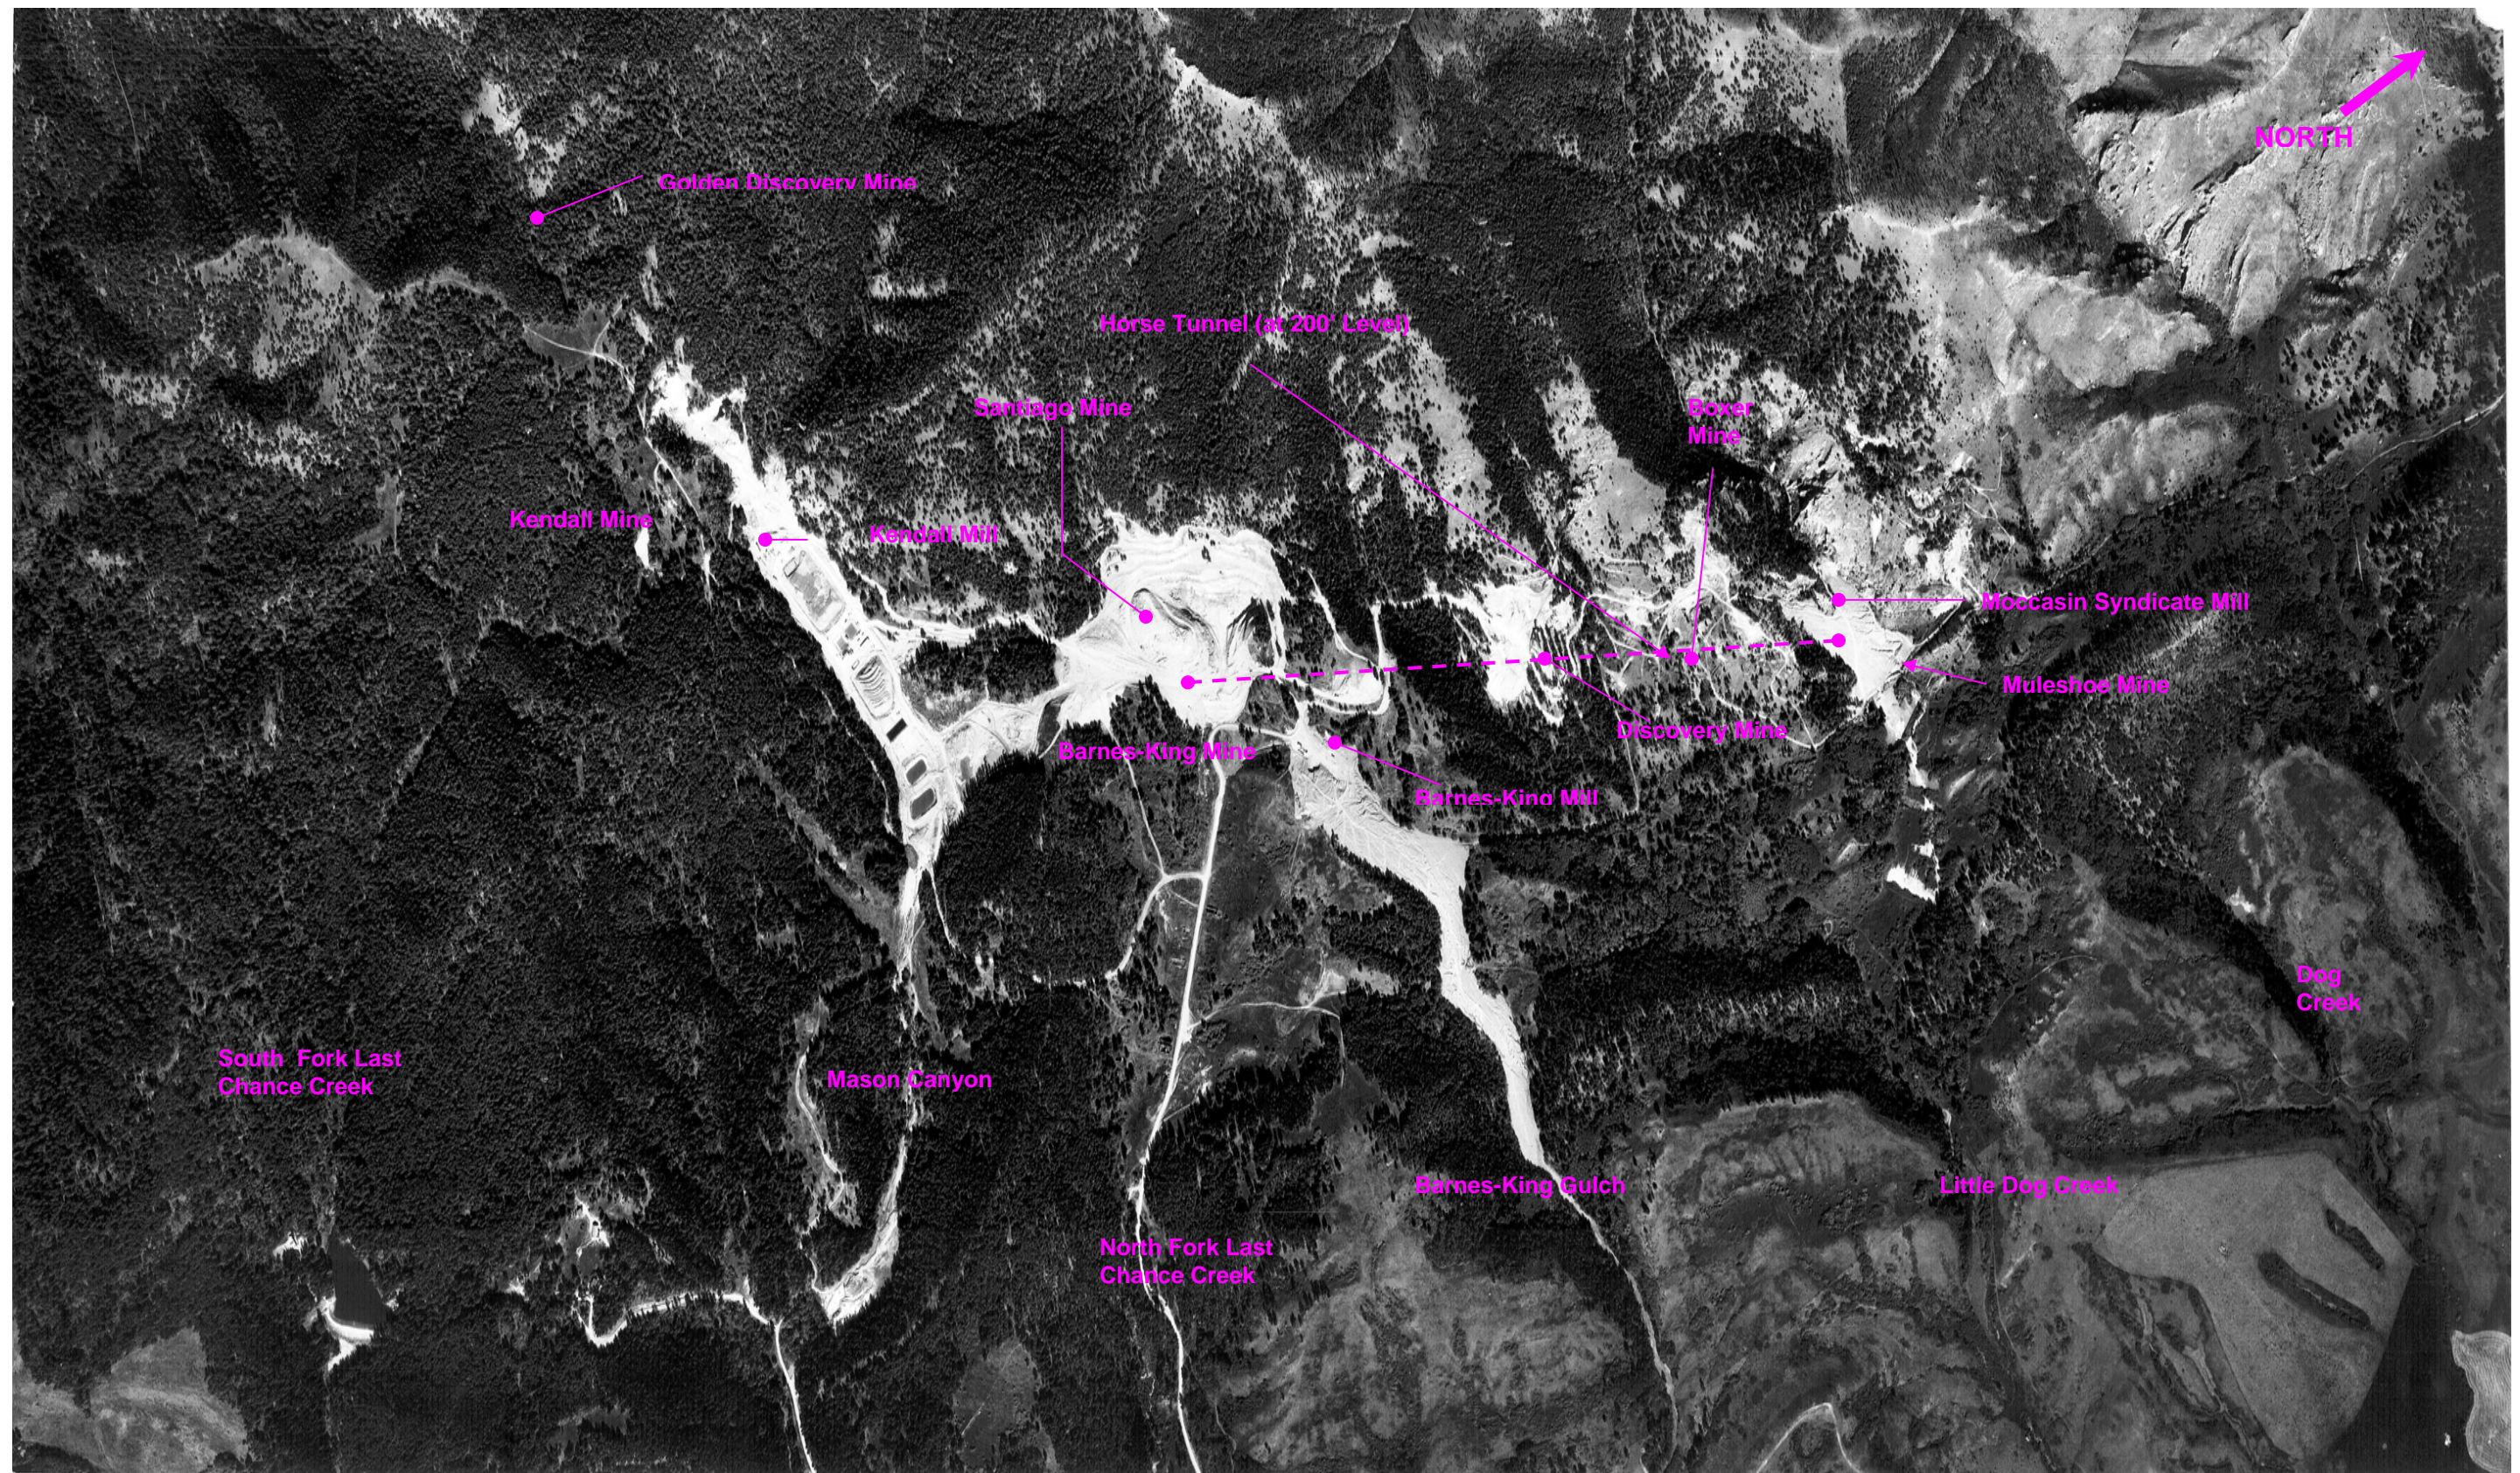
In the final years of mill operation (owners; Kendall Mine Lease, Kendall Leasing Company and E.G.R. Manwaring) gold production was only \$138,183. Assuming an average ore grade of \$3 per ton (Blixt, 1933) results in a tailings production of 46,061 tons. The total volume of tailings washed into Mason Canyon from 1900 through the end of operations is estimated to total 625,545 tons. The calculated tailings mass compares reasonably well with the estimate of 700,000 tons provided by Blixt (1933). The light colored tailings in Mason Canyon are clearly shown on all of the air photos (see Figures 3-5 through 3-7) and in the historical photo (Figure 3-4).

Figure 3-5  
Photograph of the CR Kendall Mine site and vicinity 5-23-1938

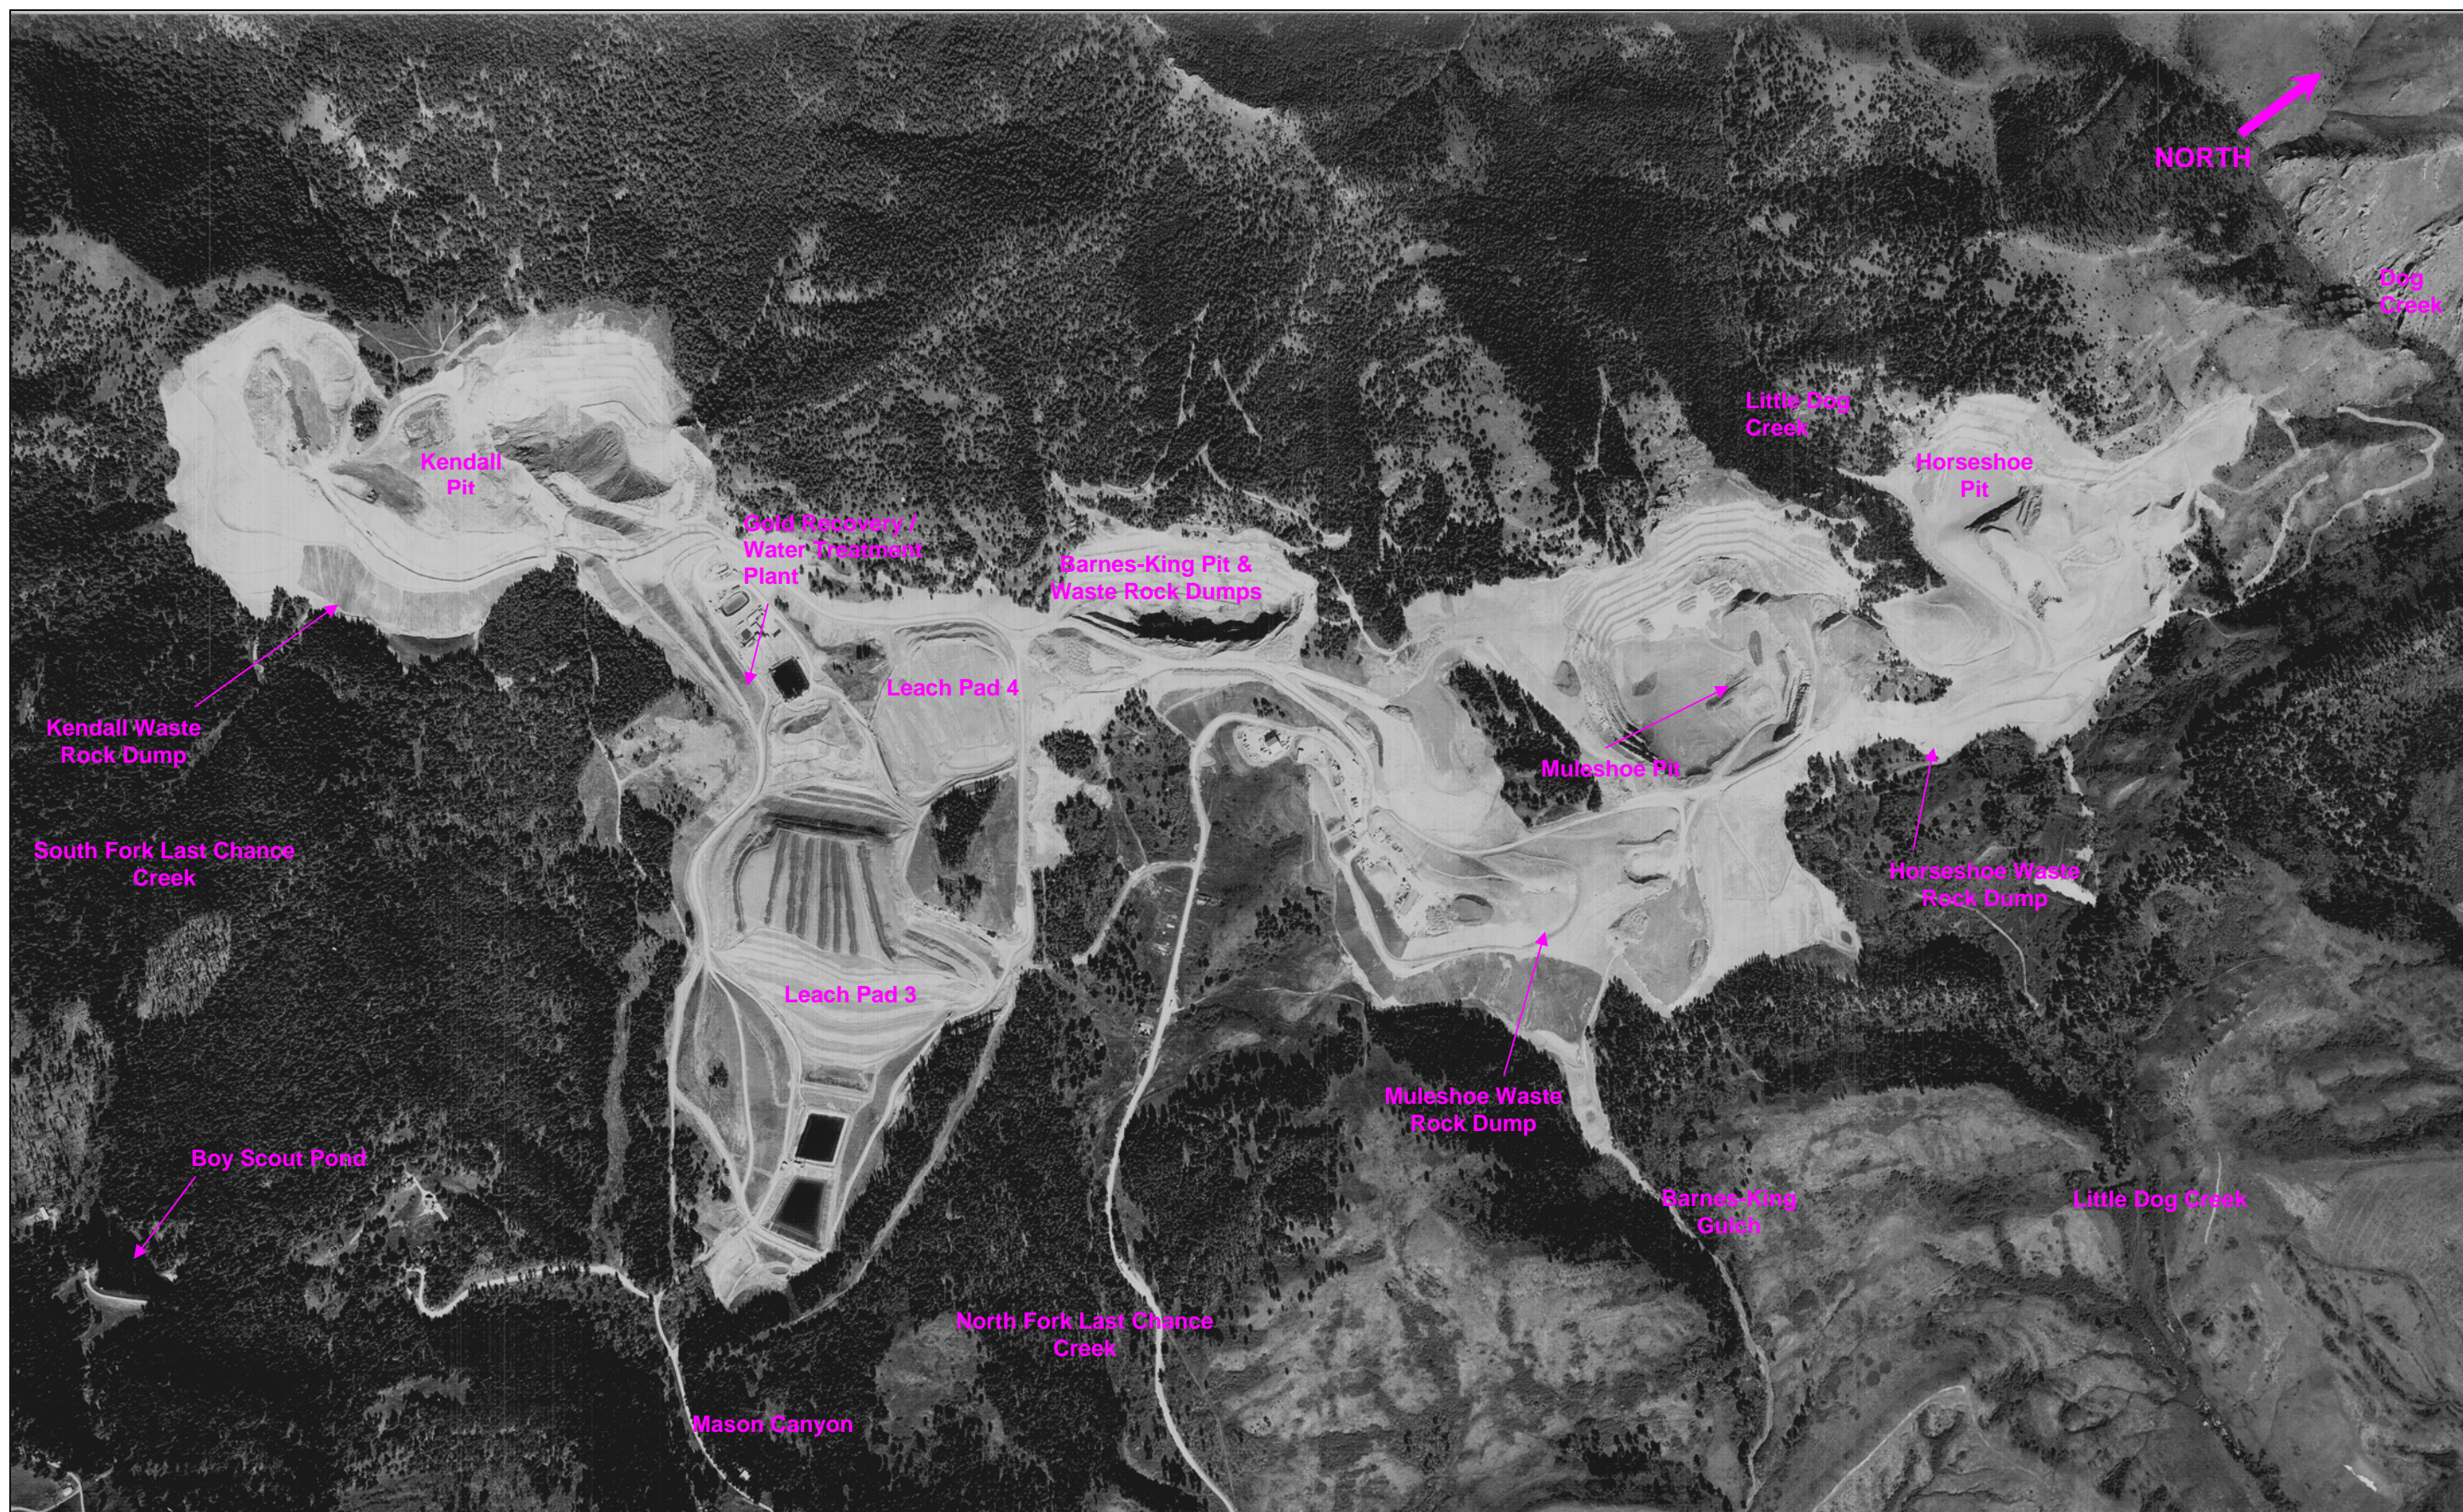
The facilities within the process valley were built directly into the historical tailings deposits, as is evident in Figures 3-6 and 3-7. In addition, historical tailings were used to construct the underliners and overliners for the new leach pads. A summary of the volumes used is provided in Table 3.1-1 (Glen Pegg Memo dated October 6, 2003).

Figure 3-6  
Photograph of the CR Kendall Mine Site and Vicinity 5-22-1988

The construction of the underliner for pad 3 was apparently underway in May of 1988, as excavations within the Barnes-King tailings are evident in the 1988 air photo (Figure 3-6). The underliner for pad 4 was constructed using historical tailings with 2% (by weight) of bentonite added to reduce the permeability. Crushed ore from the Muleshoe Pit was used to construct the overliner.

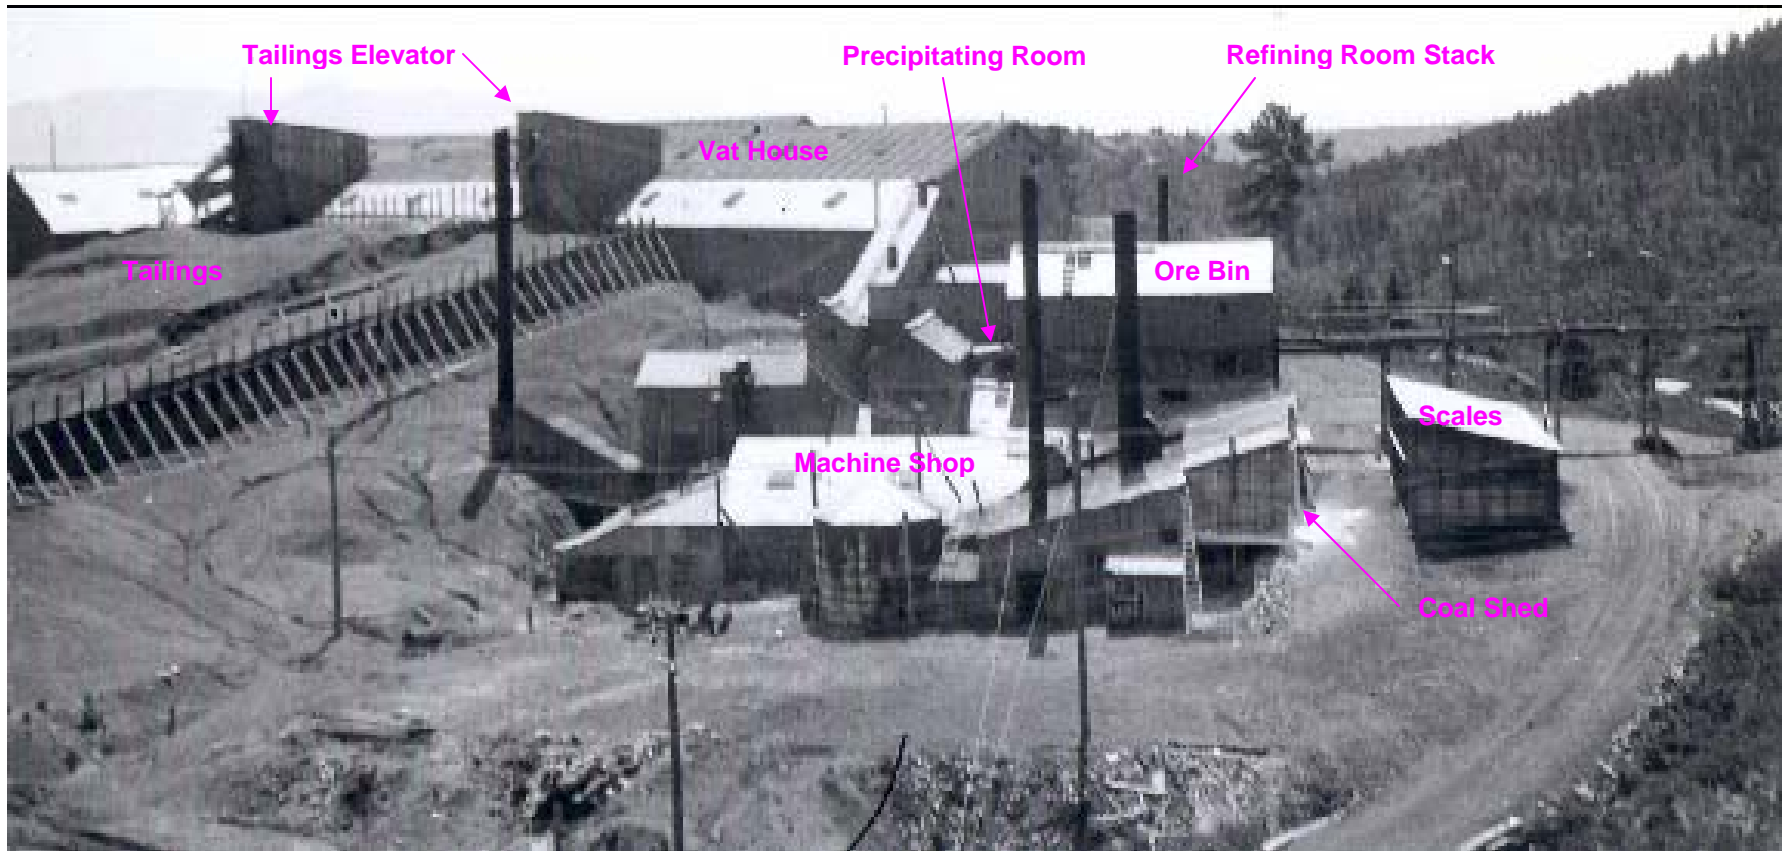
Figure 3-11  
View of the Barnes-King Mill (Circa 1909-1910) Looking South-Southwest.  
Note the Large Volume of Tailings Outside of the Vat House.  
(Photo by G.C. Morton, Courtesy of Montana Historical Society)

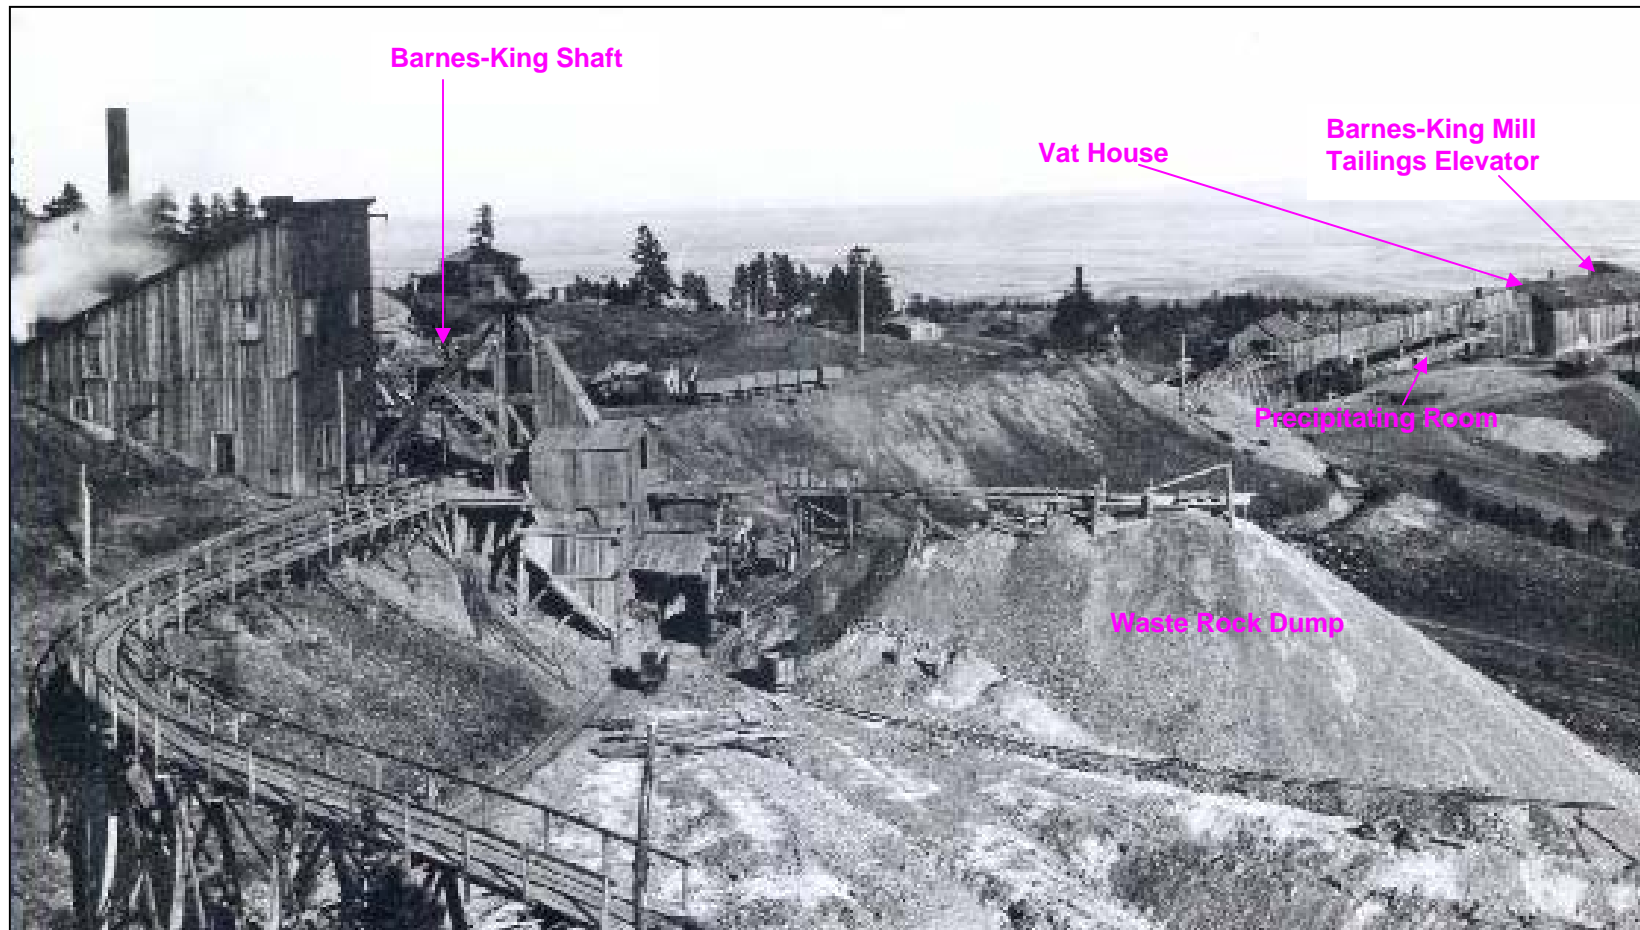
A circa 1909 photo of the Barnes-King mine and the back side of the mill is shown in Figure 3-12 (looking east). The photo shows the tram system used by the company and a developing waste rock pile adjacent to the adit. The B-K adit was located about where the Barnes-King pit was later excavated.
